Dam ID: HI00024
KALIHIWAI RESERVOIR

Inspection No: _____
Date: 20 March 2006

STATE OF HAWAII - DLNR
VISUAL DAM SAFETY INSPECTION SHEET

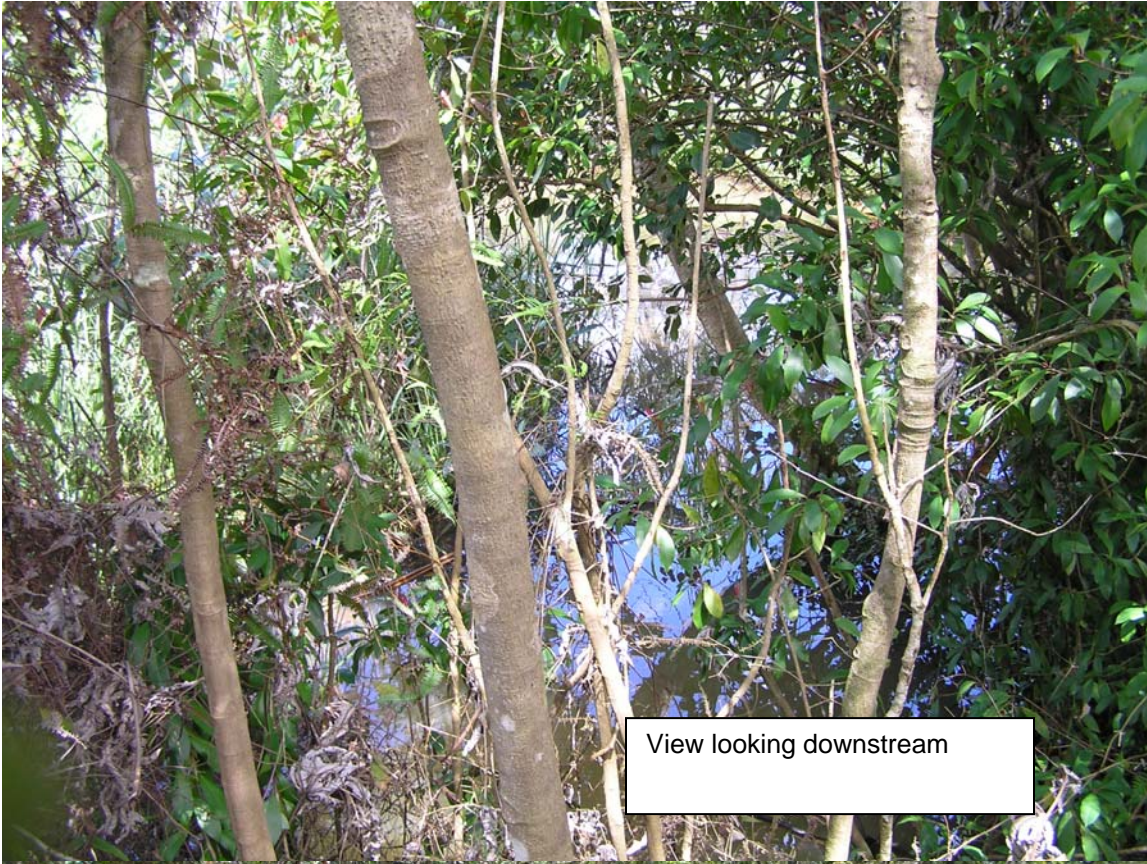
View looking downstream

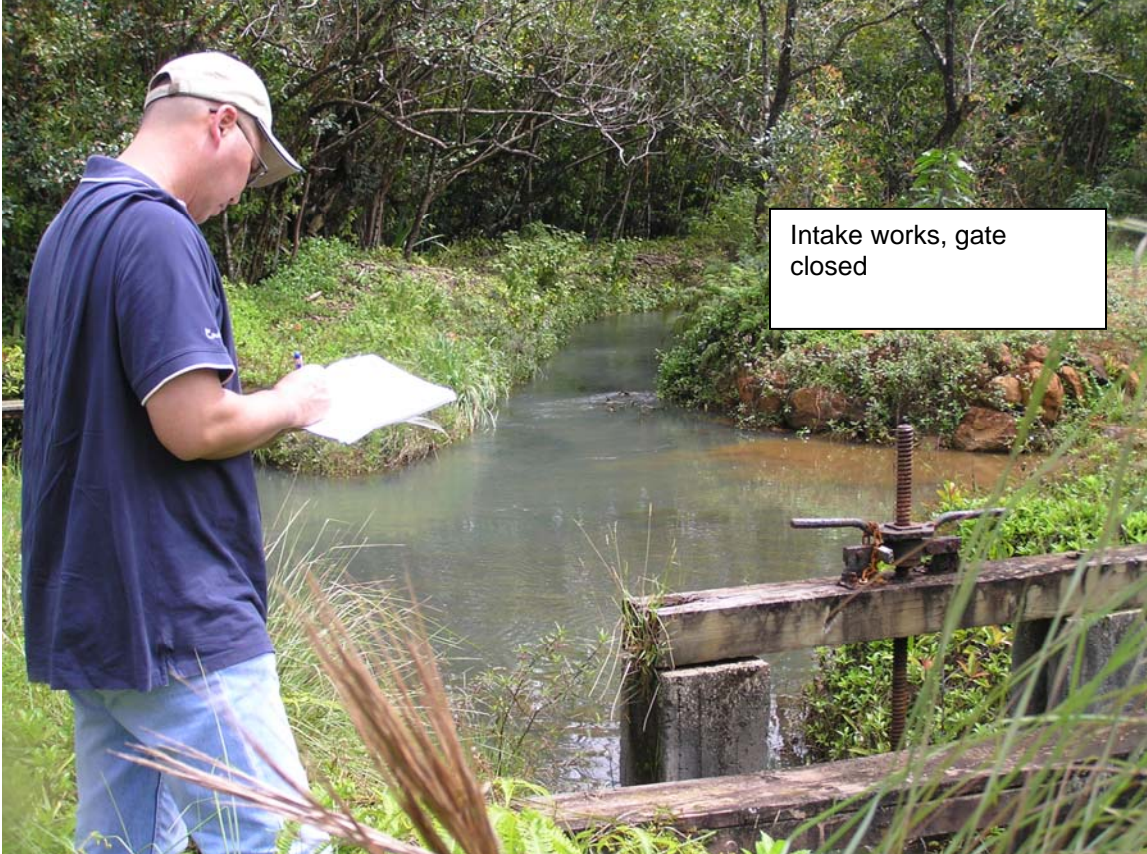
Intake works, gate closed

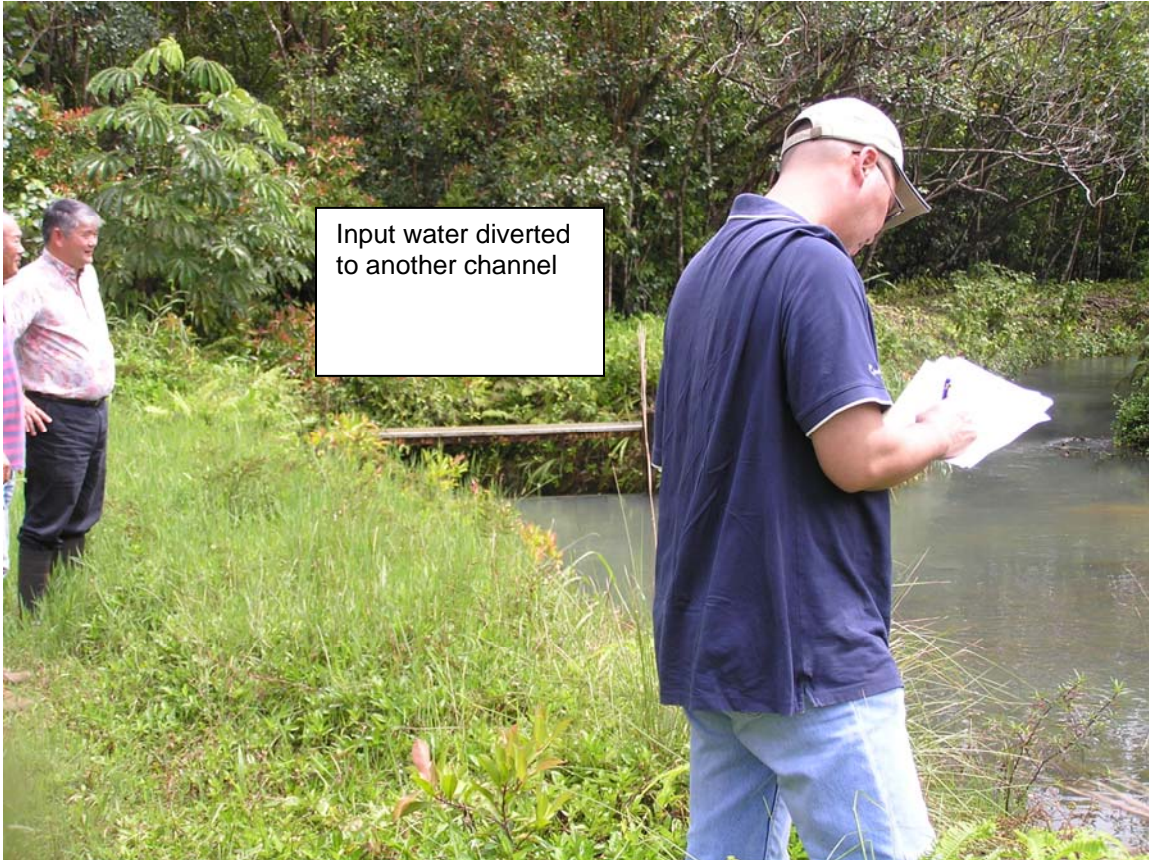
Input water diverted
to another channel

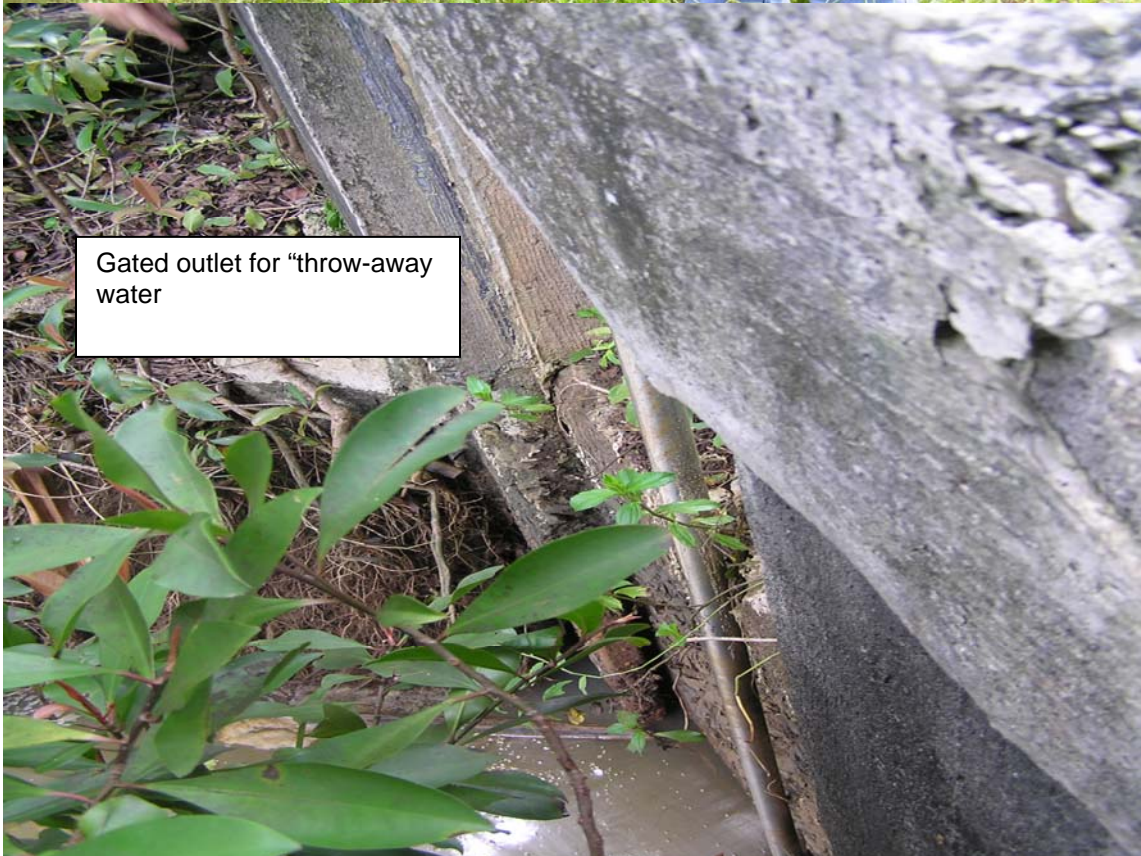
Throw away gate 4' wide, height unknown.

Gated outlet for "throw-away
water

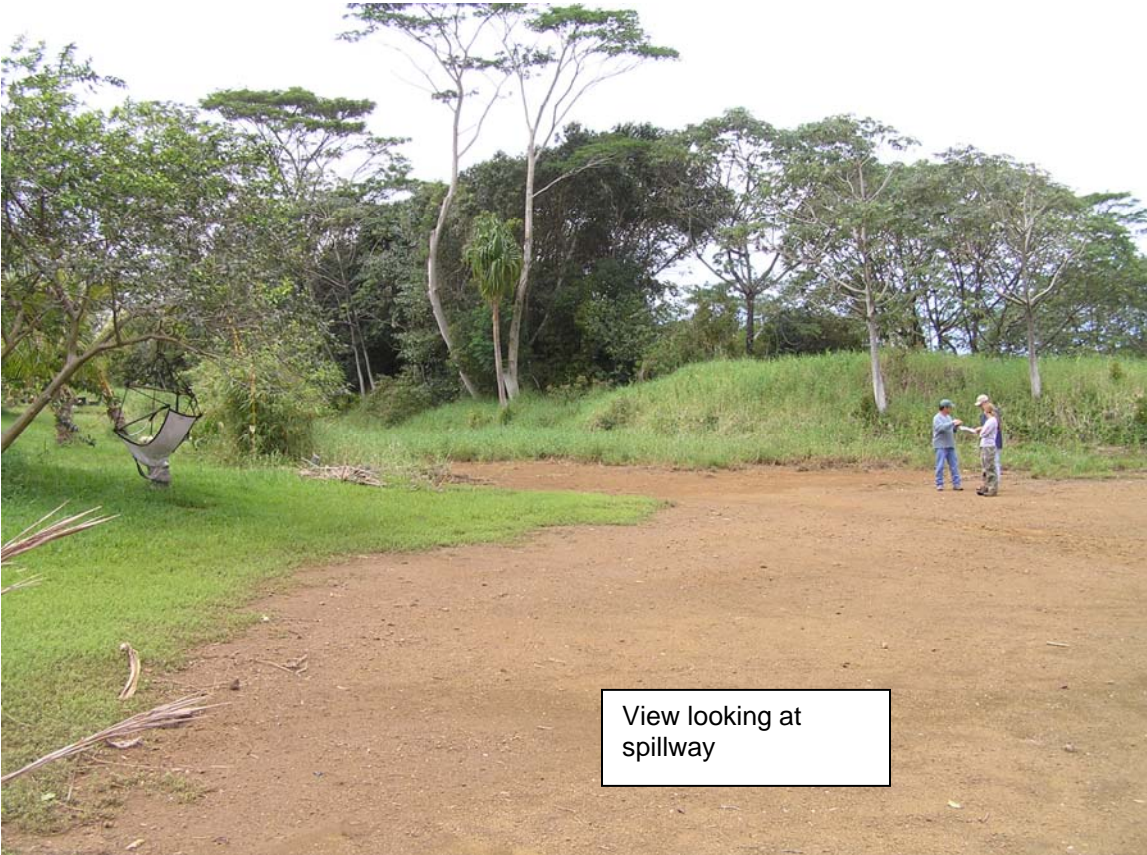
- ☐ a. The Spillway appeared to be in satisfactory condition, no corrective actions are required at this time.
- ☒ b. The Spillway appeared to be in fair to poor condition and requires corrective action.
- ☐ c. The Spillway appeared to be in unsatisfactory condition and not expected to fulfill its intended function. Urgent corrective action is required.

View looking at
spillway

- ☒ d. Slope protection needs maintenance or repair. Description: Clear vegetation/siltation.
- ☐ e. The spillway approach was blocked. Clear approach.
- ☐ f. Severe scour erosion was observed which requires maintenance and/or repair.
Description: _____
- ☐ g. A headcut was observed downstream of the spillway. Corrective / mitigative action is required to prevent this problem from moving upstream.
- ☐ h. Trees are unacceptable in the spillway channel and approach. Take corrective action to address the woody vegetation problem and repair the damaged area.
- ☐ i. Unclear if spillway is adequately sized. Spillway should pass the probable maximum flood. Verify spillway capacity and take corrective action as required.
- ☐ j. _____

Immediate: Clean spillway of vegetation/siltation and keep it cleared at all times to retain full capacity. Bottom elevation of spillway approach needs to be determined. Drain crest gullies and check for sinkholes. Sinkholes require immediate attention/corrective actions.

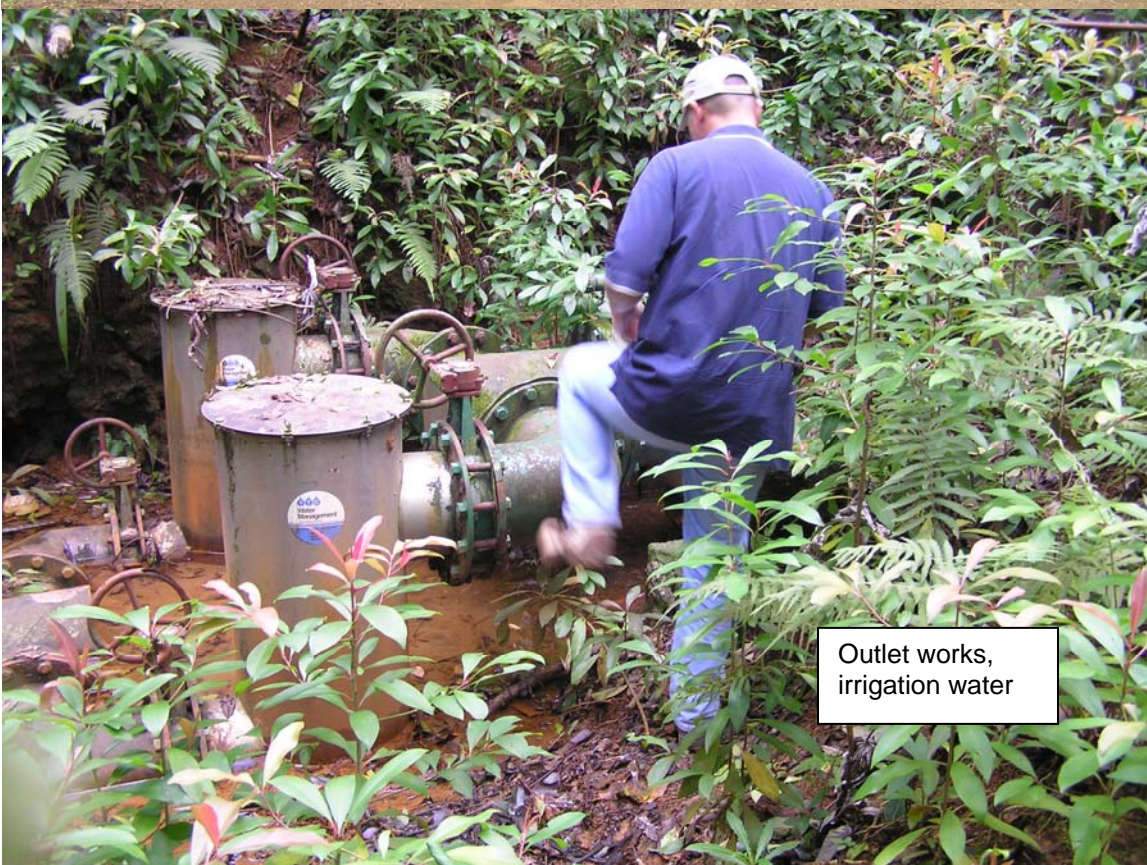
Outlet works,
irrigation water

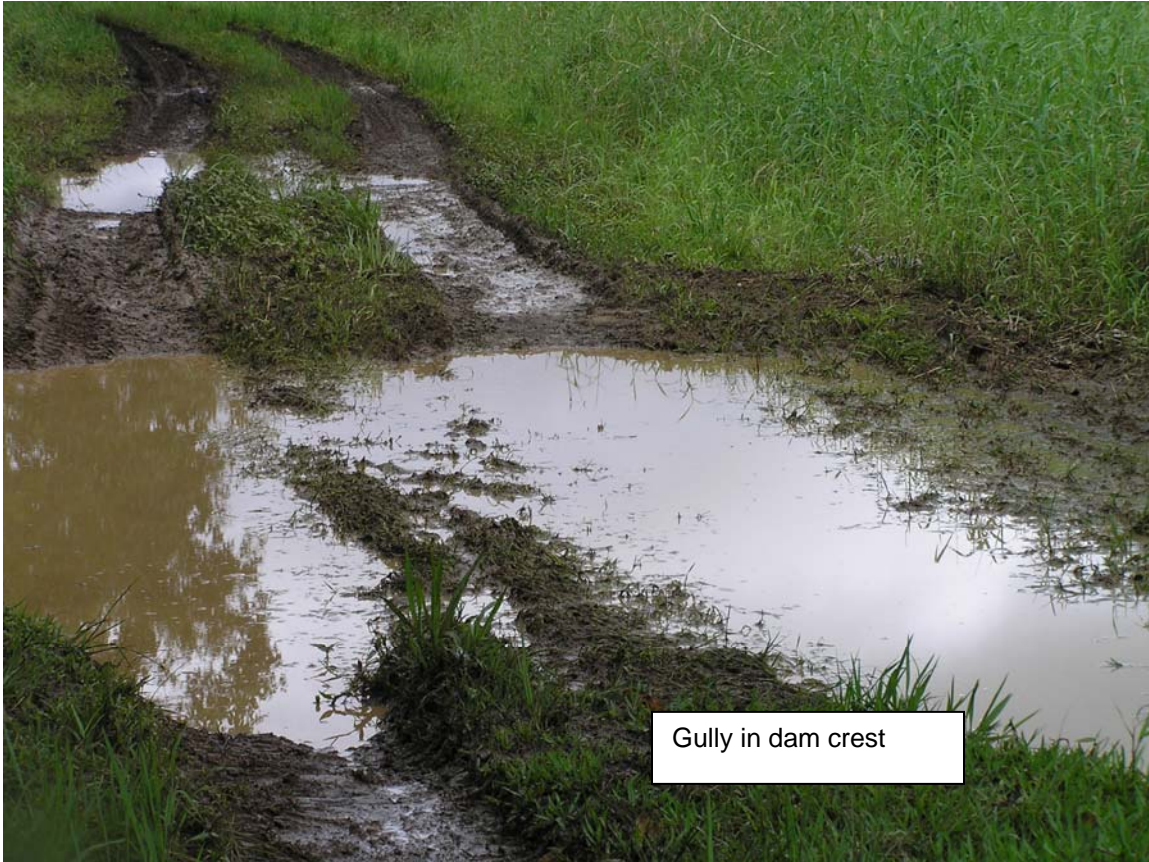
Description: large hole in road crossing crest 8' dia, 18" deep _____

- ☐ a. The dam crest was not inspected.
- ☐ b. The dam crest appeared to be in satisfactory condition, no corrective actions are required at this time.
- x c. The dam crest appeared to be in fair to poor condition and requires corrective action.
- ☐ d. The dam crest appeared to be in unsatisfactory condition and not expected to fulfill its intended function. Urgent corrective action is required.

Gully in dam crest

- ☐ e. Access along the crest was satisfactory.
- ☐ f. Access along the crest was not possible. Description: _____
- x g. Rut and/or Gully erosion was observed on the crest, which requires maintenance and/or repair. Description: _____

- x i. What may be a sinkhole was observed on the crest, which requires further investigation to determine the underlining cause. Repair and monitor the area.

Long-term: Clear all underbrush. Trim trees as close to the ground without killing them. Fill in low spots on the crest. Do detailed investigations/studies.
